North Lancing Summary of Significance

I.0 North Lancing Conservation Area: An Overview

3.0 Assessment of condition

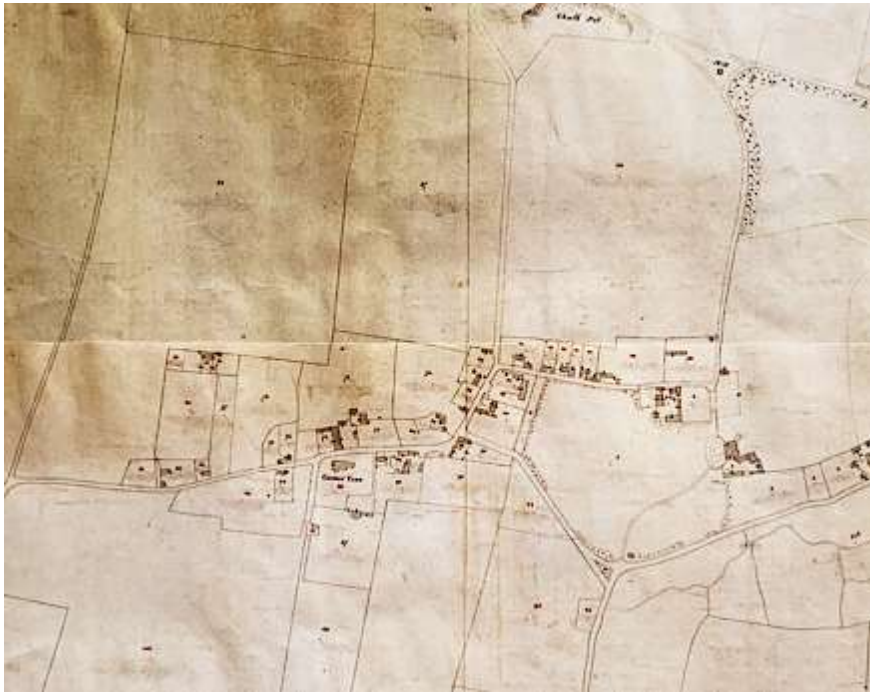
Fig 3: 1848 Tithe Map

- 2.11 The 1848 tithe map (Fig 3) shows the rural character of Lancing, and the construction by this time of Lancing Manor and its farmstead south-east of The Street. The tithe barn at the junction of The Street and Mill Road is evident, along with Smith Cottage to the south. Much of the development along the southern stretch of Mill Road and Manor Road is also in evidence by this time.

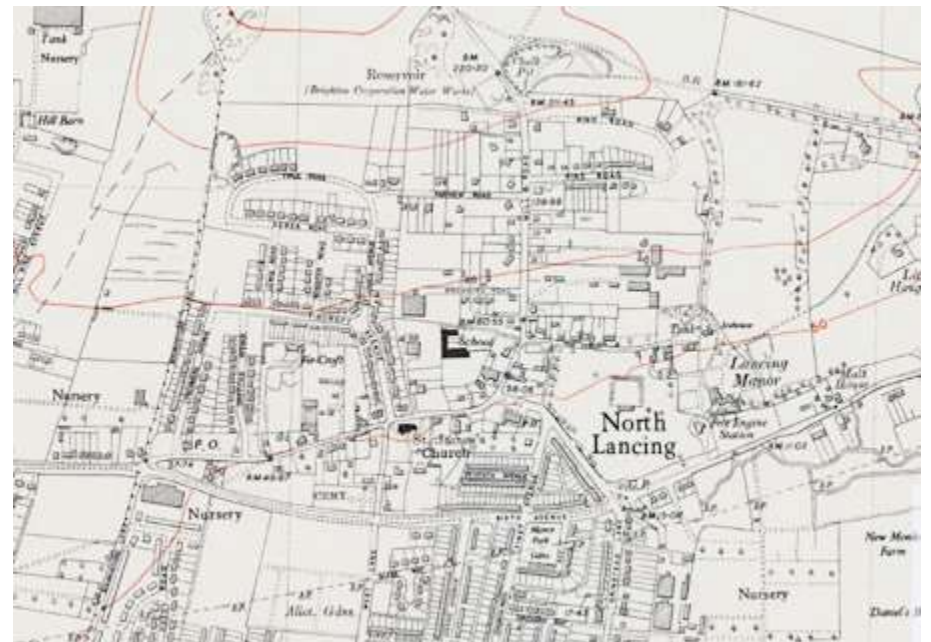
Fig 4: OS Maps 1879 (top) and 1947 (bottom)

- 2.12 The 1879 OS Map shows in greater detail the development of Lancing Manor and the lands to the north as pleasure grounds with woods, drives and summerhouses. The farmstead, icehouse, windmill and Lodge to the south are also indicated, illustrating a Manor of some grandeur. The National School for Boys and Girls is also shown by this date, along with further buildings on The Street.
- 2.13 The 19th century saw an increase in market garden industry that was common throughout Adur, principally on land around South Lancing. By 1875 there were market-gardens and orchards all around the built-up area

2.14 The opening of the London and Brighton Railway Carriage Works in 1912 served as a major catalyst for residential development which expanded rapidly across the district in the interwar years. The two OS Maps of 1879 and 1947 show the considerable suburbanisation of the landscape over this period.

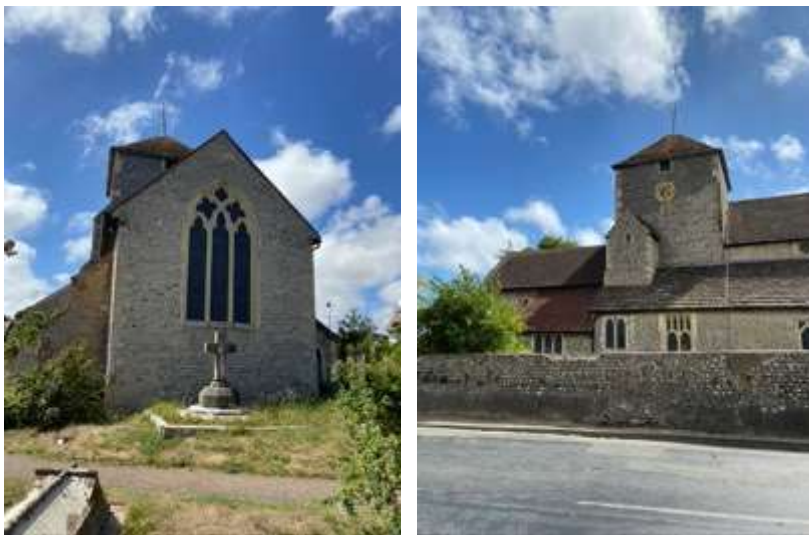
Fig 7: St James the Less

St James the Less is a landmark building with a pyramidal tower and long north elevation set above and fronting Manor Road.

- 3.4 Historic North Lancing is a village centred along three streets: Manor Road, Mill Road and The Street. Manor Road follows a gentle south-west to north-east route and has a number of listed buildings along it including the predominantly 13th century church of St James the Less, which is a landmark building in the conservation area. This sits opposite Church Road Farmhouse, believed to have been the site of the Saxon settlement and the medieval centre of the Manor of North Lancing. Manor Road joins Mill Road at the characterful Old Cottage and continues north towards the Downs. While historic buildings terminate a short way along Mill Road, the road steepens here inviting exploration to find the rewarding views from higher ground.

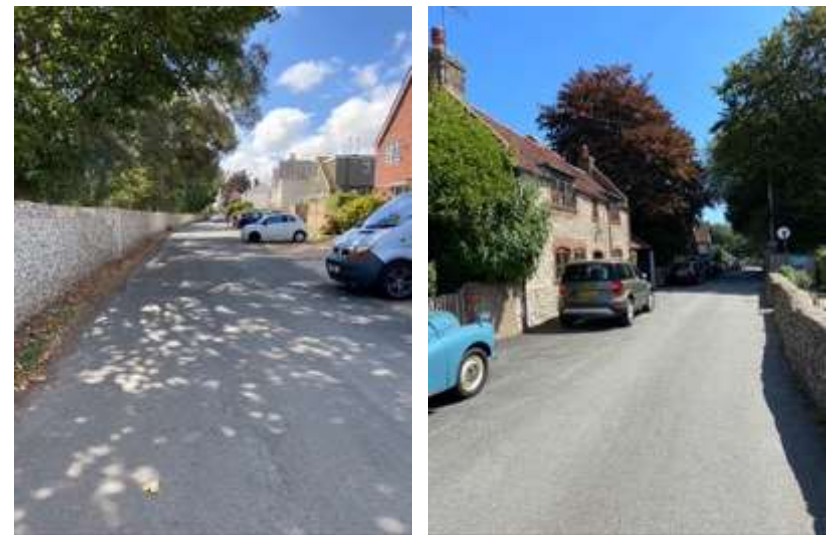
Fig 8: Views along The Street from the east (left) and west (right)

- 3.6 Of the three roads in the historic settlement, The Street has the greatest concentration of historic buildings, mostly of 18th or 19th century date, and a variety of detached, semi-detached and terraced properties, with varying plot sizes and alignments to the road. The Street is narrow, and has a high sense of enclosure owing to the houses built up to the road on the north side, and a tall flint wall with mature trees overhanging it from the park to the south. A narrow twitten runs south from the west end of The Street between two flint walls marking the edge of the conservation area at the west side of Lancing Manor Park.

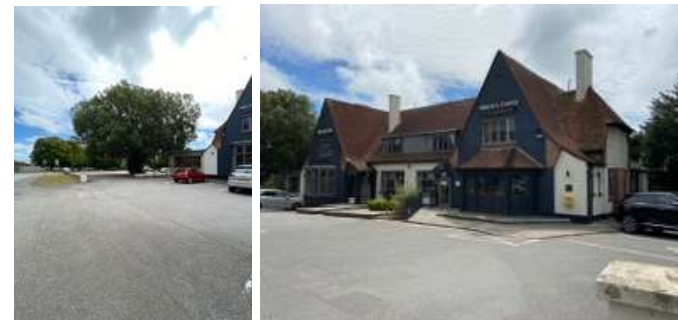
Fig 9: Miller and Carter public house and its setting

- 3.7 The short section of Mill Road within the conservation area is at the confluence of the three roads, and therefore allows wider townscape views to the east, west and north. The age of buildings here is varied, ranging from the 15th century timber framed Old Cottage and 16th century Grants Manor, to the Victorian school and interwar public house. The forecourt to the public house provides a clear view of the pub and the mature Holm Oak trees in the car park, but there is a poor sense of enclosure here. The green open space south of the pub provides a verdant backdrop both to the pub, and the edge of the conservation area.

- 3.18 Of 20th century buildings, the public house is the most noteworthy. It includes many of the hallmarks of the later Arts and Crafts style with steeply pitched roofs, prominent weatherboarded gables, tall chimney stacks and a low slung long flat roofed dormer to the front.

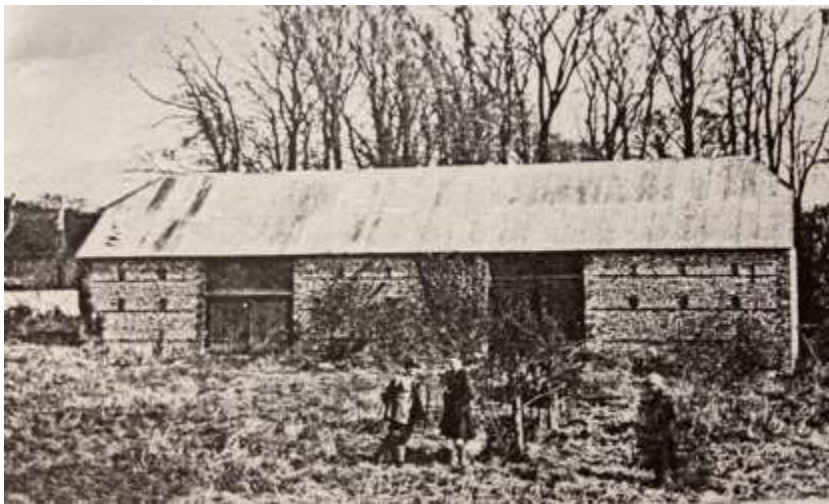
3.10 The pattern of historic buildings is similar to that recorded in the mid 18th century although there have been some regrettable losses in the latter part of the 20th century including most notably the demolition of Lancing Manor in 1972, and of the tithe barn at the junction of The Street and Mill Road. Most of the infill development is on subdivided plots which has created a tighter grain of development, but some larger buildings have also been introduced including the 19th century school, the Miller and Carter pub around 1930, and the modern flats on the site of the old tithe barn.

Fig 12: The old tithe barn in 1922 (top) and after its conversion and further development (bottom)

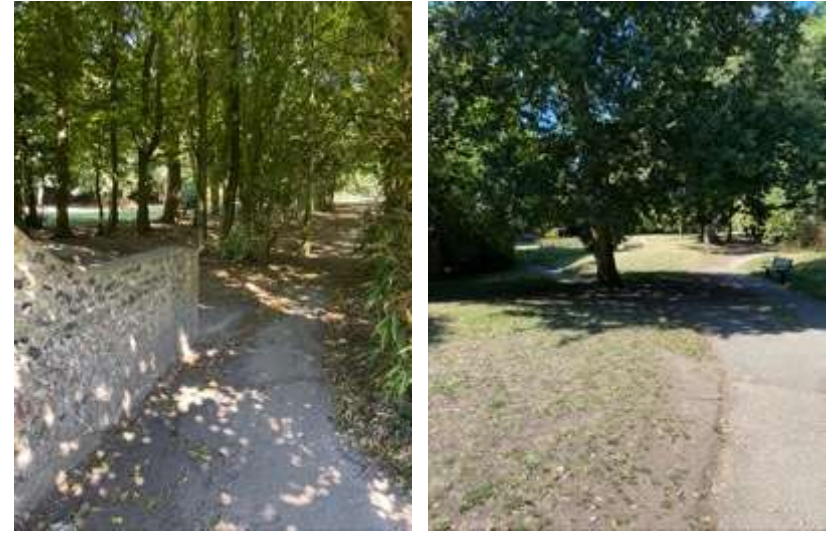
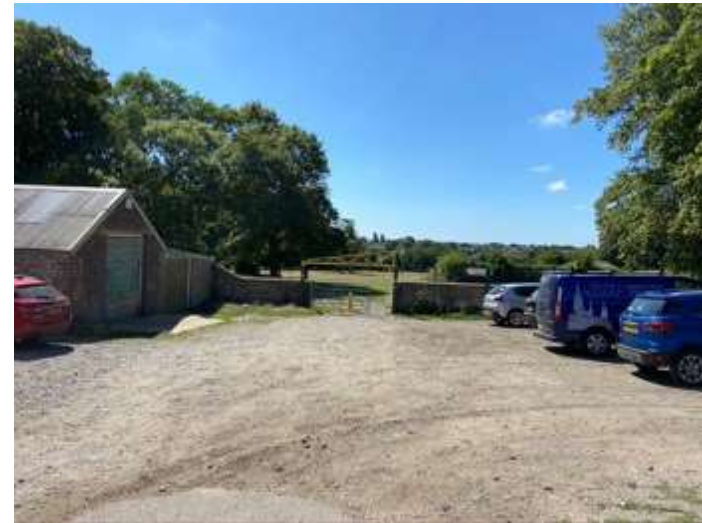
Fig 13: Views around north-east end of Lancing Manor Park

3.12 At the east end of the revised conservation area boundary is a section of parkland that roughly corresponds with the built remains of the now lost Lancing Manor. It comprises an important area of open space and is characterised by the remains of the courtyard farmstead and pleasure grounds.

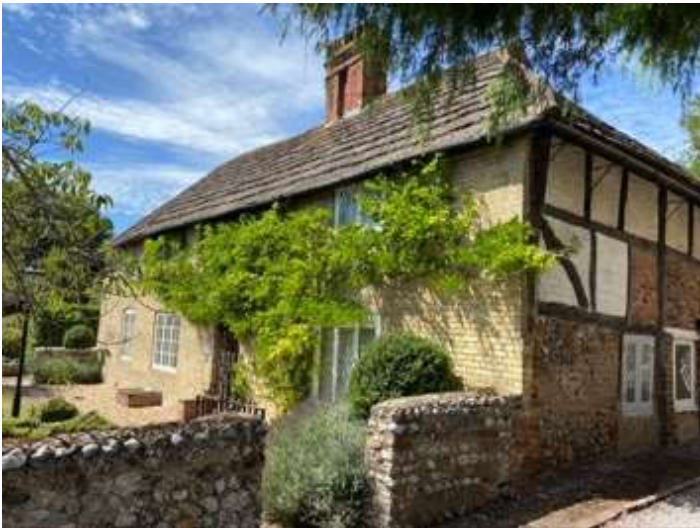
Fig 14: Grant's Manor

- 3.14 The three good quality timber framed vernacular buildings in the conservation area are all listed at grade II. Grants Manor (previously known as Walnut Tree Cottage and The Old Posting House) and Friar's Acre (formerly Brickhouse Farm) have both been re-fronted, but date from the mid 16th century. These buildings have gabled roofs and central stacks suggestive of their lobby entrance plan.

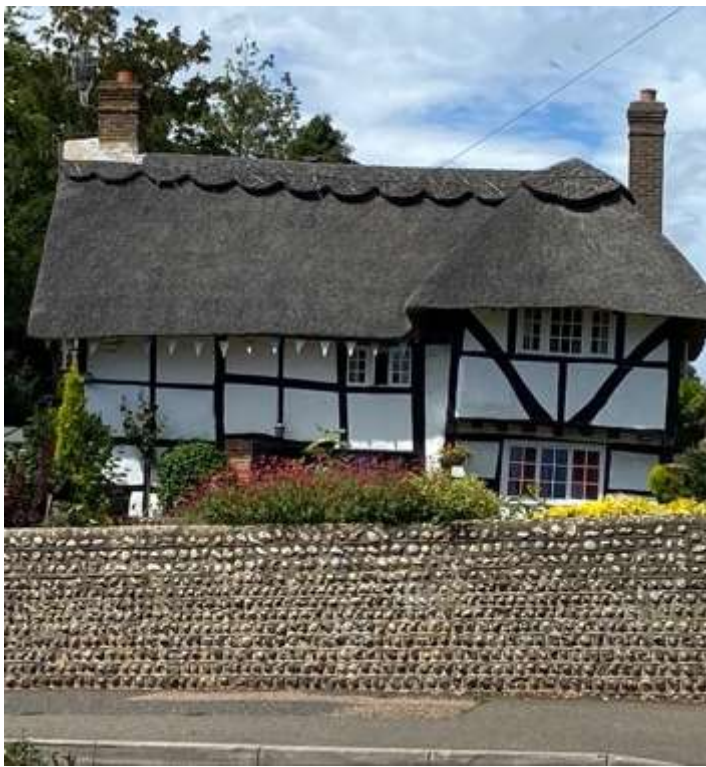
Fig 16: The Old Cottage

- 3.15 The Old Cottage is a landmark building in the conservation area located at the junction of Manor Road and Mill Road, where its striking black and white timbered and part jettied front, deep thatched roof and long garden with herbaceous borders strongly evokes a long-lost rural idyll. It is likely to be one of the very oldest buildings in the village with parts dating to the 15th century, and anecdotes abound as to the provenance of its ancient timbers and unsubstantiated tales of visits by Queen Elizabeth I and James II.

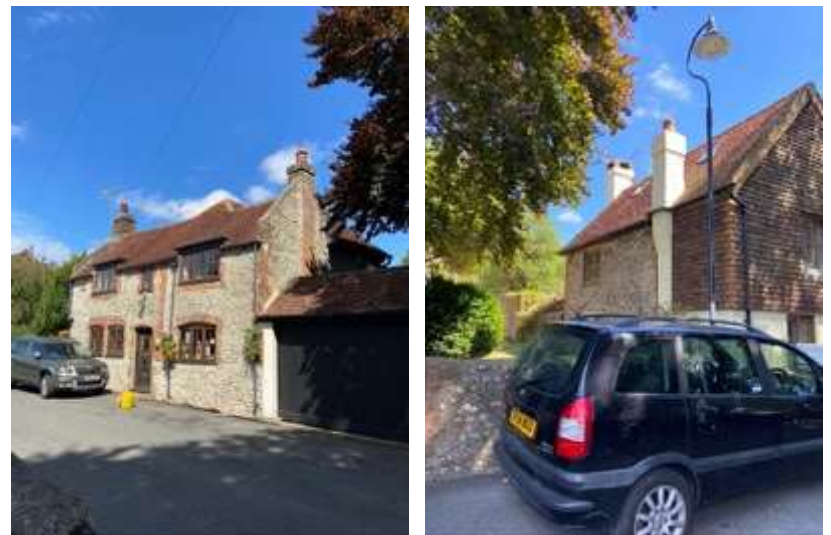
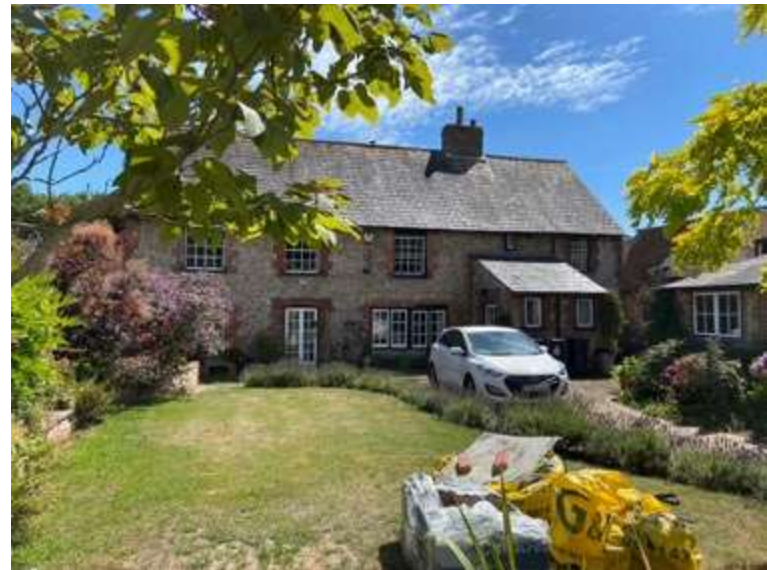
Fig 17: Typical 18th century buildings: Hawthorn Cottage (left) and Twitten Cottage (right), Smithy Cottage (bottom)

3.16 There is a scattering of 17th or 18th century buildings throughout the conservation area. The majority are vernacular flint buildings, either modest cottages or buildings of agricultural origin and now converted to residential use. Along The Street, 18th century examples include Hawthorn Cottage, previously several dwellings, and Twitten Cottage. Smithy Cottage and the Old Forge are on Mill Road and also date from the 18th century. Smithy Cottage is an attractive flint building with brick dressings built in the polite domestic Georgian style. The Old Forge was heavily altered during its conversion in the 1920s.

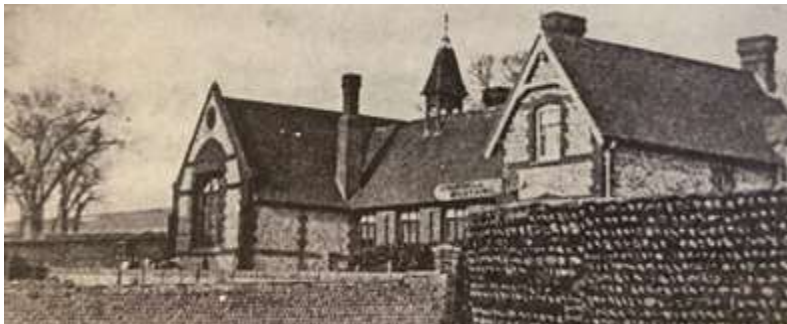
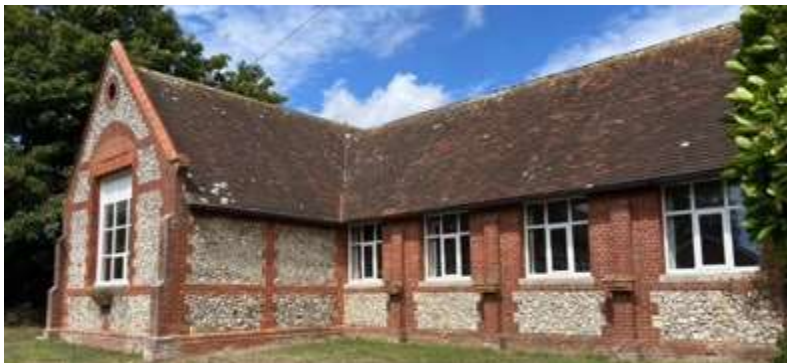
Fig 18: The Church of England School 1900 (top) and present day (bottom)

- 3.17 There are also some good 19th and 20th century buildings throughout the conservation area including notably the 1872 school, built to the designs of local architect Richard Came comprising the school hall and a house for the Mistress at the east end. The photographs at Fig 18 show the form of the school largely as built, although missing the belltower on the central ridge. It also shows the clear views to the Downs north of the school, a view that has been lost to later development.

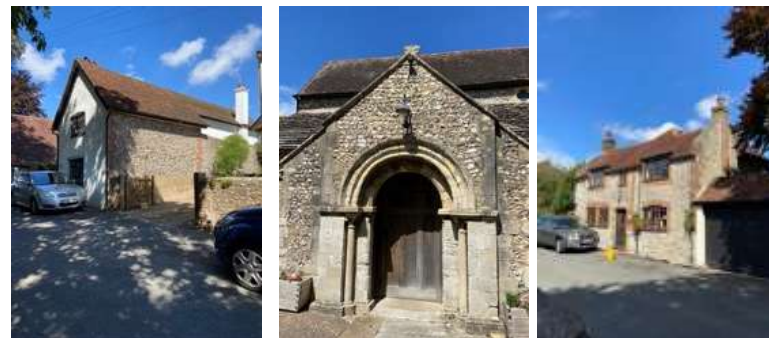
- 3.21 The most characteristic of the local building materials is flint, found in the chalk beds of the downs, or on the beaches. The most commonly found broken flints are known as field flints, and would have been ploughed up for use in buildings. They can also be knapped and coursed, but no examples of this higher quality flintwork exists within North Lancing. Flint is used extensively throughout the village, both in buildings and the boundary walls.

Fig 19: Flint with brick or stone, flint walls

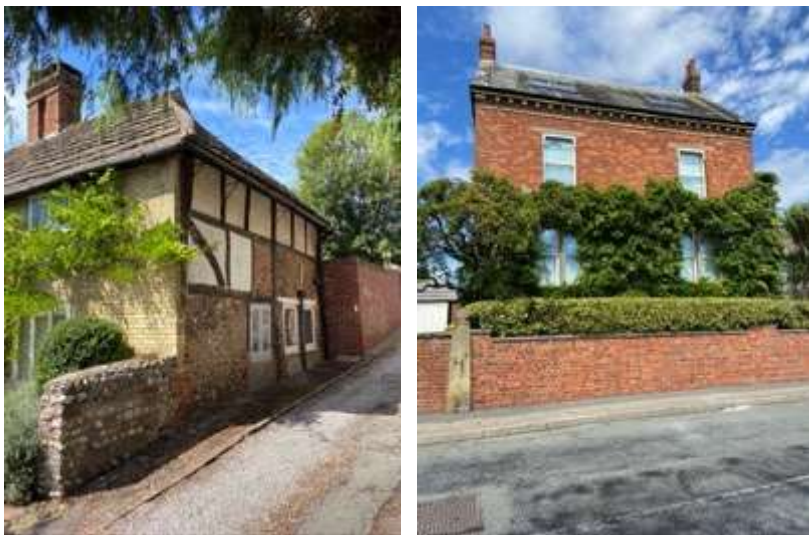
- 3.22 Elsewhere, brick is common, usually in local red clays, but also unusually at Grant's Manor in yellow London clays. Modern buildings tend to use mass produced hard bricks of various colours. Where historic, brick is most frequently laid in Flemish bond, but also often rendered. Red bricks are frequently used in window and door dressings on flint buildings. There are examples of tile hanging, although often on more modern buildings or additions, and roofing materials include both clay tiles and slates. Additionally, there is some localised use of Horsham slab roofing, for example on the north aisle of the church and at Grant's Manor; and of weatherboard again on more modern buildings, or where they have been altered.

Fig 20: Use of brick in the conservation area, Horsham slab to roof of Grant's Manor

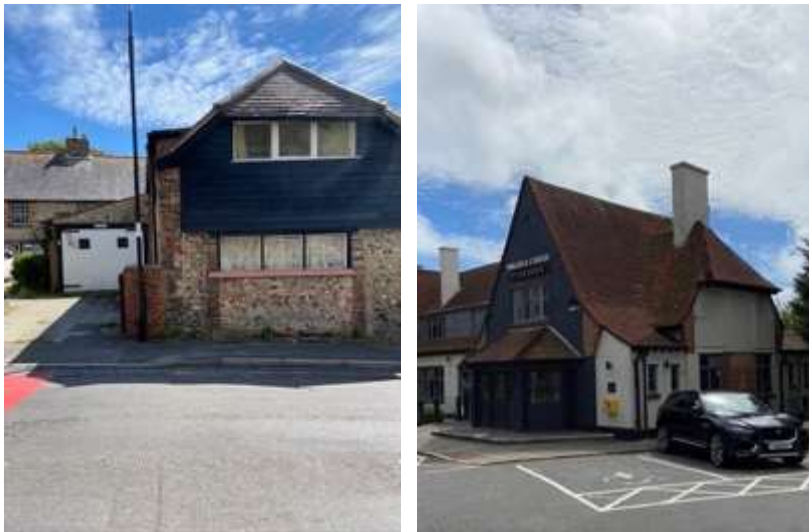
Fig 21: 20th century use of weatherboard

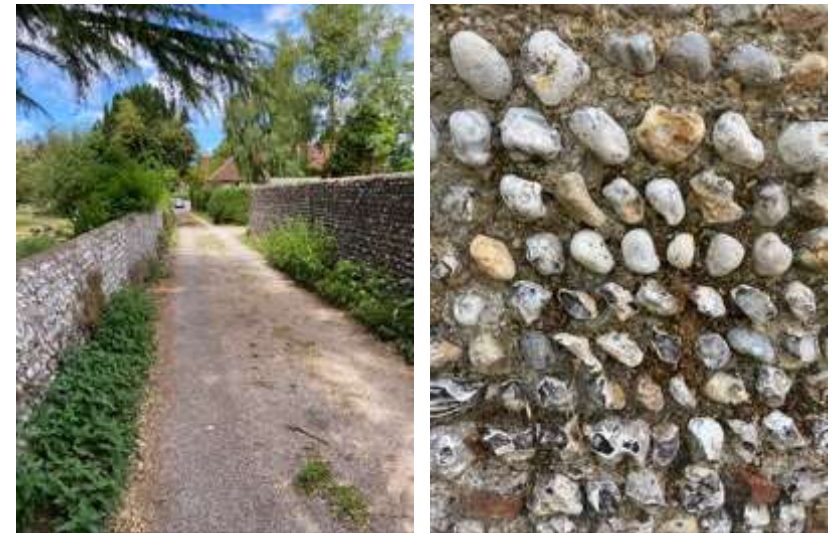
3.24 The flint walls are not homogenous, but vary in terms of their height, intactness, quality and age. Some are built of coursed cobbled flints, while others are made of field flints laid in a more random arrangement. Older walls tend to be taller, bonded with granular lime mortars, while the more modern walls are generally lower, with brick dressings and cement mortars. In North Lancing, there are some poor imitations utilising gravel sized flints set into mortar panels. Future use of these should be discouraged.

Fig 22: Historic flint walls

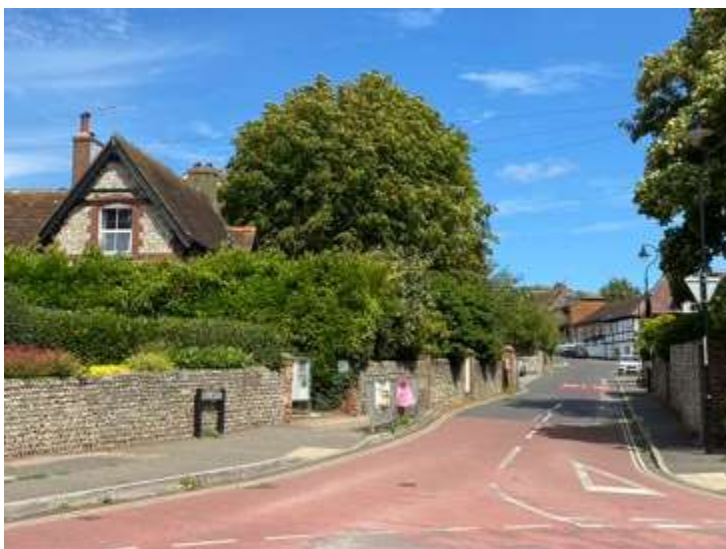
3.25 Mature hedges and shrubs and trees are also a feature of the conservation area, frequently growing behind flint walls. There are also areas where enclosing features are absent (for example at the public house), or where provision of off-road parking has resulted in the removal of sections of flint walling. Some properties have introduced close boarded fences to street frontages which are harmful to the character of the conservation area.

Fig 23: High hedges over flint walls on Mill Road

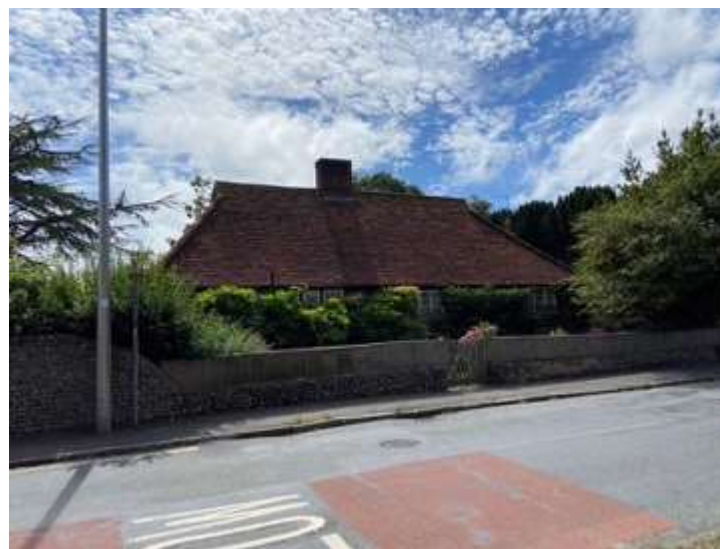
Fig 24: Close-boarded fence over reduced flint wall

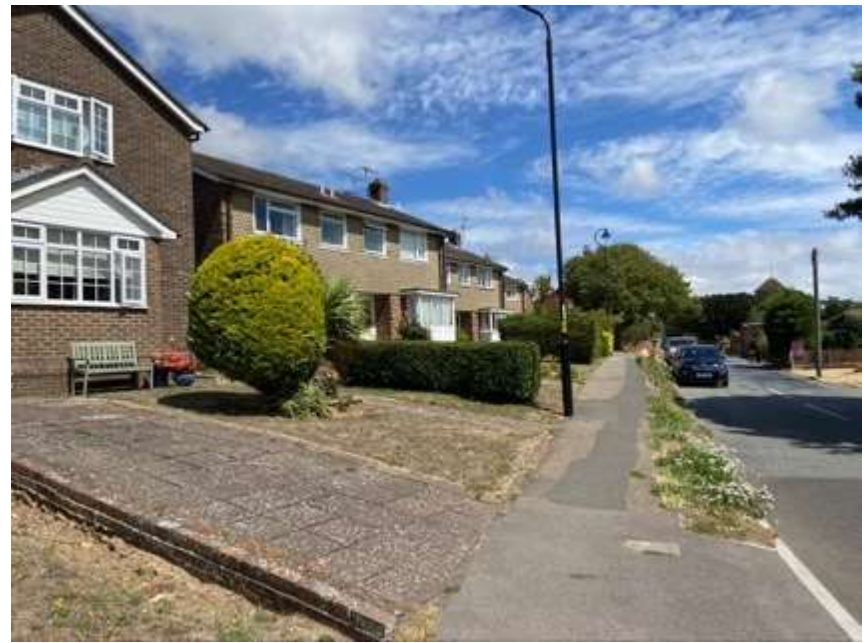
- 3.31 The review of this conservation area has also identified a number of buildings and areas that make no positive contribution to the character or appearance of the conservation area, and they have therefore been proposed for removal in the recommendations below. These include the modern housing west of the Greenoaks cul-de-sac north of Manor Road. There is a significant length of modern housing on both the north and south sides of Manor Road here, and its inclusion in the conservation area is not justified. It is proposed to create an adjunct to the main conservation area to protect the small group of 19th century buildings on the north side of Manor Road before it gives way once more to modern development beyond Nursery Close and Griffiths Avenue.

Fig 28: Modern housing on north side of Manor Road west of the church

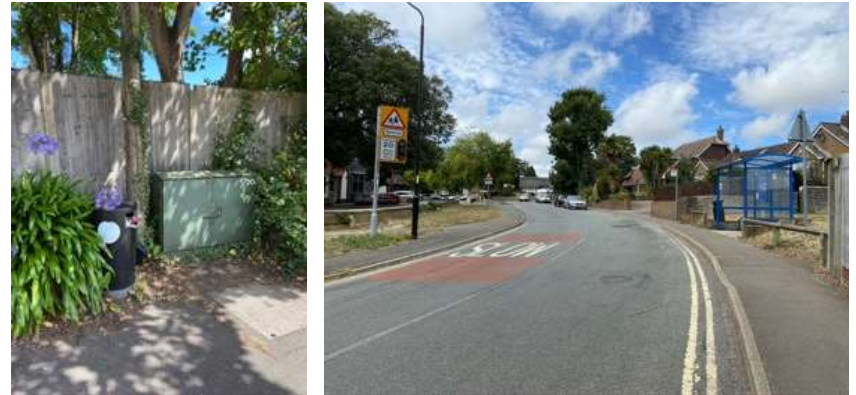
- 3.33 The area around the junction of Manor Road and Mill Road has also been identified as a negative space in the conservation area. It is a key arrival point into the conservation area but the townscape qualities here are poor. The unattractively screened electricity sub-station and bus stop detract from a sense of arrival. The car park to the public house, along with the unattractive road markings, fences, and street furniture here also detract from the setting of The Old Cottage and the school, and are harmful to views west along Manor Road and north along Mill Road.

Fig 29: Negative spaces around the junction of Mill Road and Manor Road

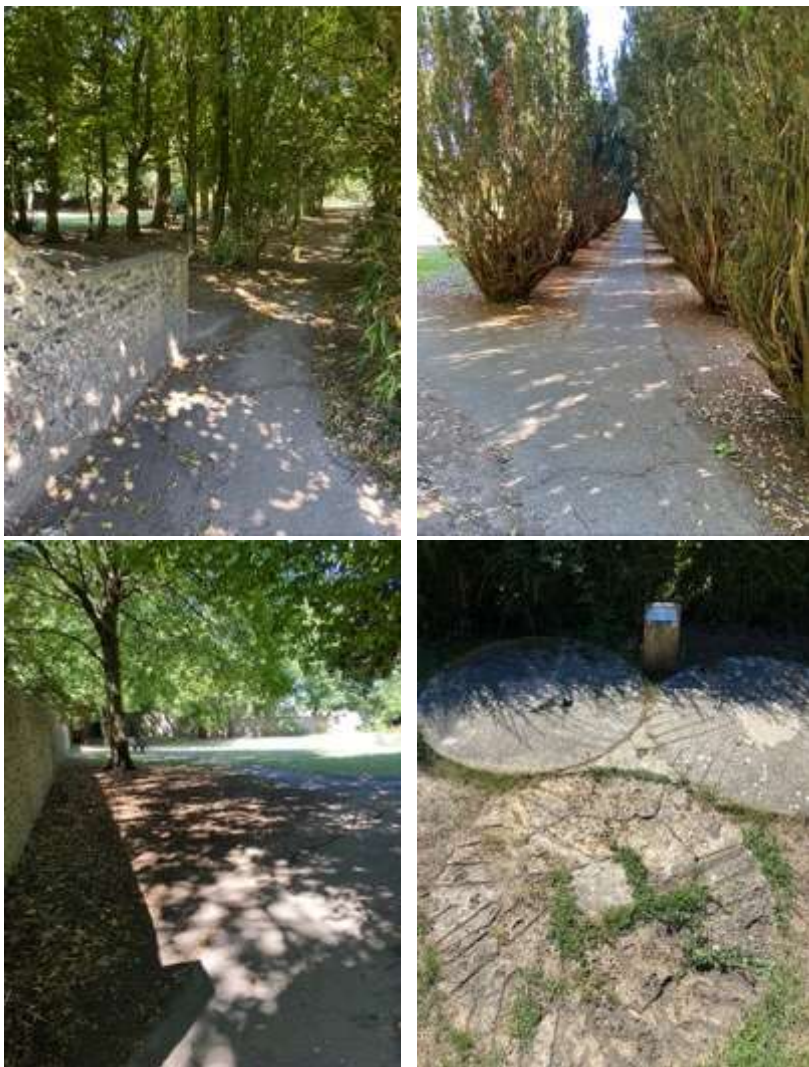
Fig 31: Historic features within Lancing Manor Park

- 3.38 Today, this part of Lancing Manor Park has a character distinct from the majority of the space where the leisure centre, bowling green and children's playground evoke a municipal feel. The north-eastern section is heavily wooded, and there is evidence of the former use of the land in the form of remnant flint walls to structures or orchards. A short avenue of yew trees survives, and the millstones of the former flour mill have been relocated to this area from the site of the lost mill further north.

3.39 Along the north boundary of the park are the recorded remains of the former icehouse. This is beneath trees and its condition is unknown. From here, footpaths wind through the wooded western edge of the park and open onto expansive fields further east, before converging on footpaths leading to the Downs. There are remnant flint walls from earlier parkland walks or drives throughout the woods here, and further north is the site

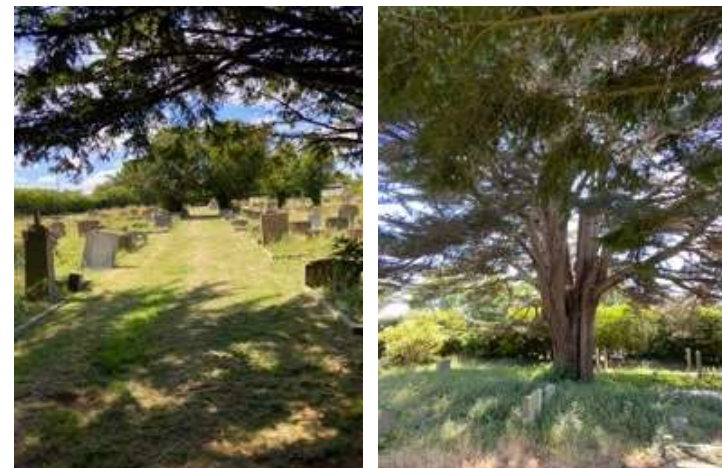
Fig 33: Burial ground on Upper West Lane

3.40 South of the parish church at the southern end of Upper West Lane, there is a small burial ground containing some 19th century, but mostly 20th century burials. A footpath runs from the east entrance to the west end of the site and there are a number of mature yew trees within the grounds that are worthy of protection.

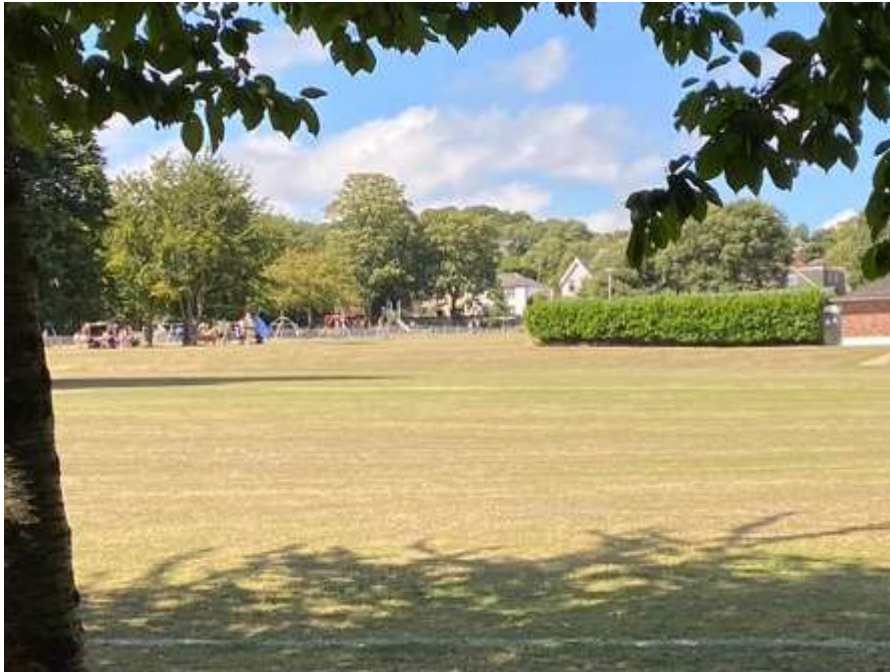
Fig 34: Setting of the conservation area: a view across the park to The Street

- 4.1 North Lancing village is on the low slopes of the Downs, with continuous development down to the coast and significant development north of the village before it gives way to the countryside. The setting of the conservation area is therefore a suburban one, and one that has harmed the legibility of the historic settlement. Lancing Manor Park is the one remaining open space seen in the context of the conservation area, but its historic character has mostly been eroded with the demolition of the Manor House, construction of the leisure centre and installation of other leisure facilities.

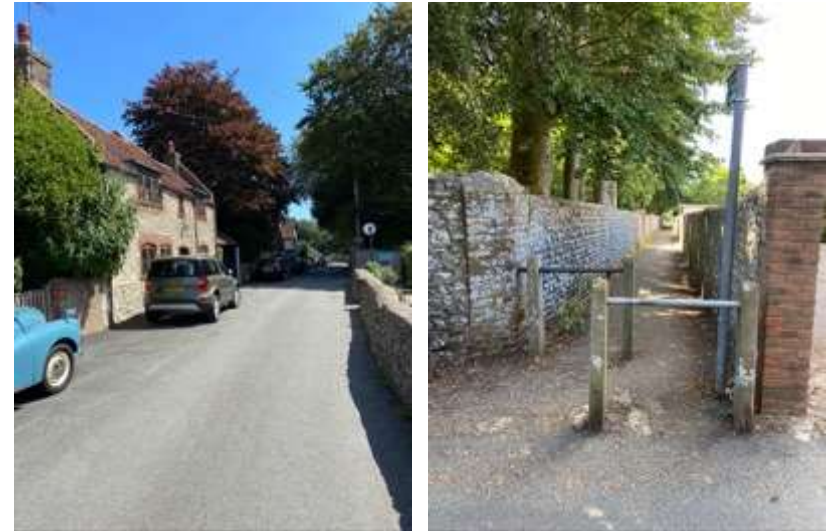
Fig 35: View east along The Street, and south along the twitten at the west end of The Street

- 4.3 The Street is a narrow linear road, with a high sense of enclosure owing to the flint walls on the south side and the overhanging mature trees which create dappled shade in the summer. The views along The Street have historically been much photographed and remain important today.

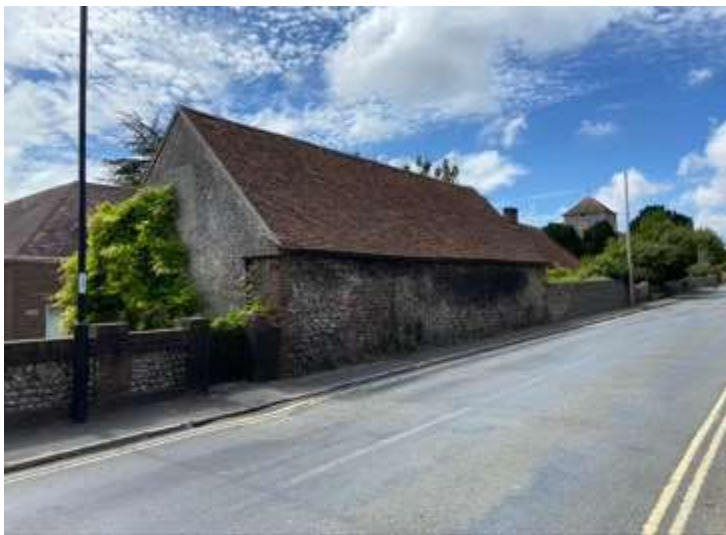
Fig 36: View looking west along Manor Road towards barn and church tower

- 4.4 Further important townscape views are those available from the junction of Manor Road and Mill Road. From here, the church tower is visible behind the long elevation of the flint barn sitting hard on the south side of the road; while looking from a vantage point by the pub, The Old Cottage, School and Old Forge are all visible with Mill Road climbing away beyond.

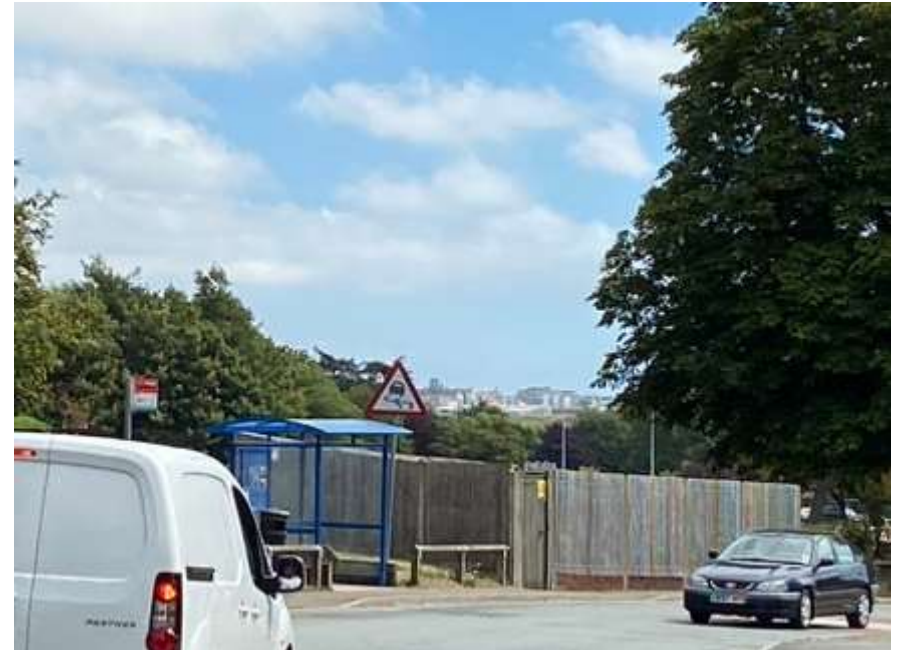
Fig 38: Long view east towards Brighton

- 4.6 One long view is available from within the conservation area at the east end of Manor Road looking out towards Brighton in the far distance, but the foreground is spoiled by the substation, bus stop and signage. The view serves as a reference point.

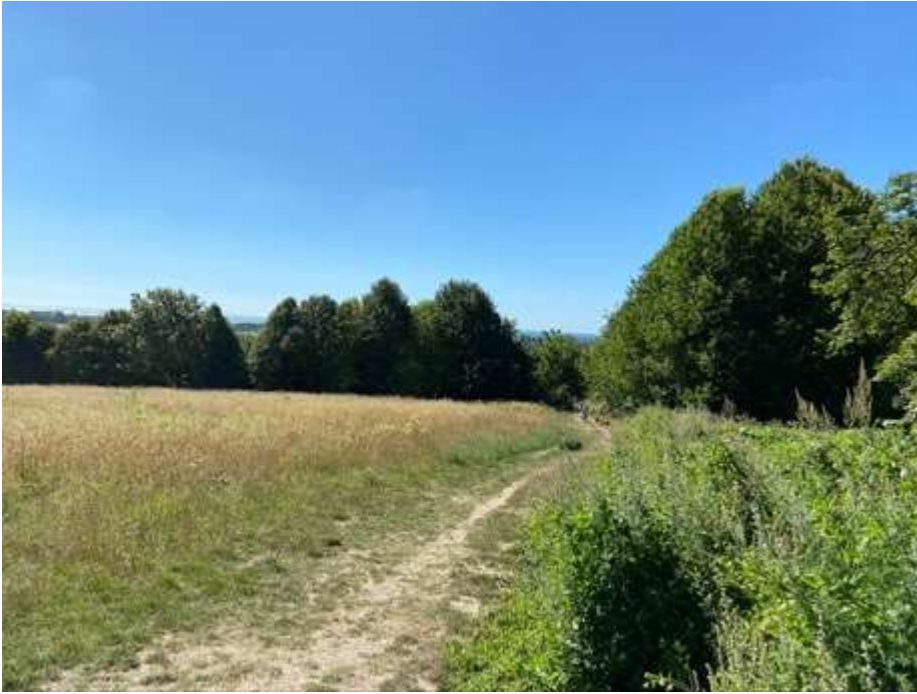
Fig 39: View from footpath north of Lancing Manor Park

- 4.7 There are limited views into the conservation area, because the topography and vegetation conceal the settlement from higher ground to the north, however the view south from the fields north-west of Lancing Manor Park provides expansive views towards the sea which is visible over treetops. This is on land previously belonging to Lancing Manor and where summerhouses are marked on the 19th century maps. It is likely that views here would have been more open in centuries past, the trees fortuitously having now grown to conceal the modern development below.

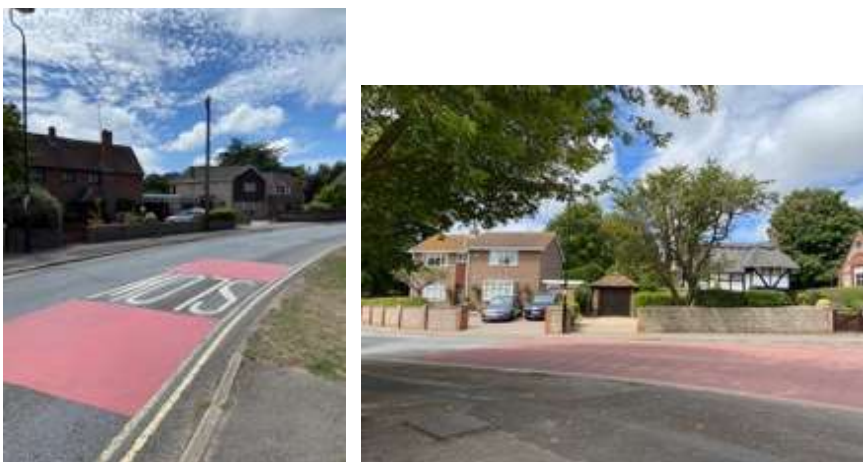
5.2 Buildings that benefit from statutory designation have been afforded greater protection than those elsewhere that have in some cases suffered inappropriate alterations often resulting in the removal of historic or traditional windows or doors, or loss of or alterations to historic boundary treatments. Modern residential development for the most part pre-dates the designation of the conservation area, and is in many cases inappropriate in terms of design or materials used.

Fig 40: Modern development adjacent to The Old Cottage (left) and on south side of Manor Road (right)

- 6.7 Some of the modern development throughout the conservation area is poor quality and makes little reference to local vernacular materials and designs. As proposals come forward for redevelopment, or alteration of buildings in the conservation area, the design guide issued with this appraisal should be used to inform decision taking.
- 6.8 Regrettably, most of the original windows and doors to historic buildings within the conservation area have been lost, and have frequently been exchanged for uPVC or historically inaccurate replacements.

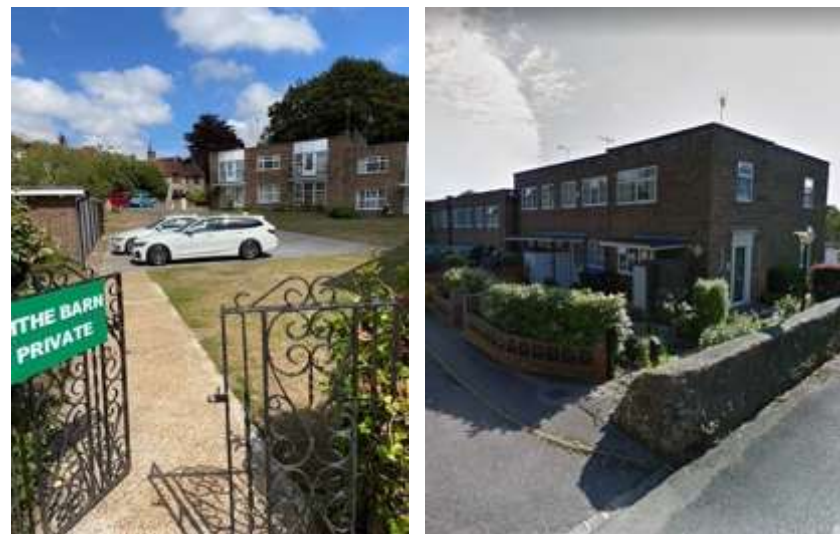
demolition of Lancing Manor in 1972 and its replacement with the modern leisure centre. The tithe barn was in need of considerable repair when it was converted in 1922, but its subsequent extension and then demolition is lamentable. The flats that replaced the tithe barn were designed with the scale and position of the historic barn in mind, but the design is inappropriate by current standards, and the materials alien to the conservation area.

Fig 41: Modern flats on site of old tithe barn

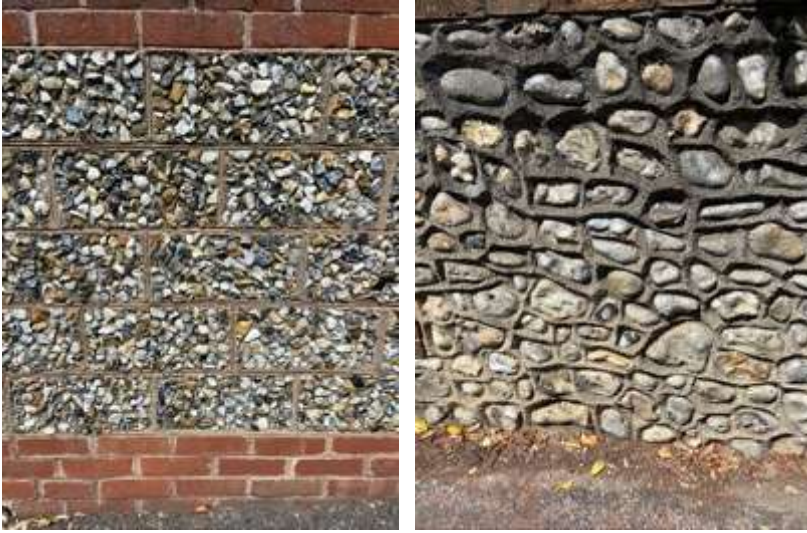
- The quality of the public realm is generally poor. Street surfaces, street furniture, telecommunication infrastructure and signage all detract from the appearance of the conservation area.
- The setting of the public house detracts from the aesthetic appeal of the building itself, and from the character of this central zone of the conservation area.
- There are damaged or missing sections of flint walls, or uncharacteristic modern flint walls

Fig 42: Modern inappropriate flint wall and poorly repaired historic wall

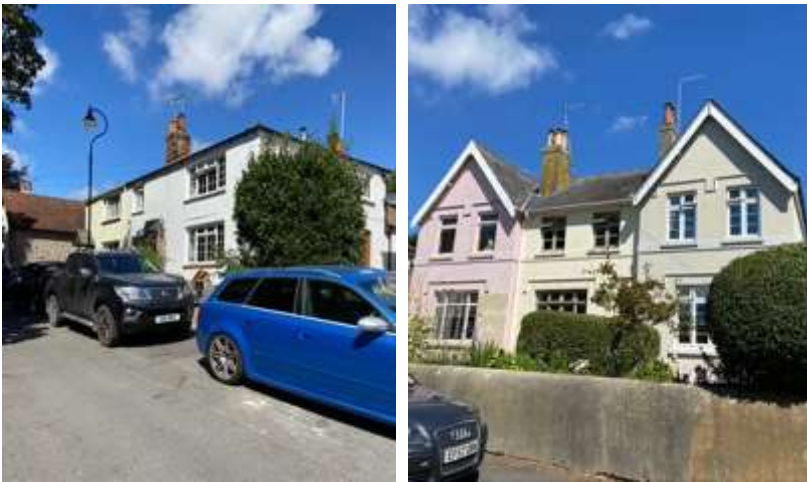
- Many original windows and doors to unlisted historic buildings have been lost with inappropriate, or uPVC replacements.

Fig 43: Modern uPVC windows to unlisted historic buildings
